# Manhole Inspection Summary

Manhole # S61I\_\_031MH

Insp Date: **7/8/08 9:14 AM**

**Location** Address: **524 s quail st**

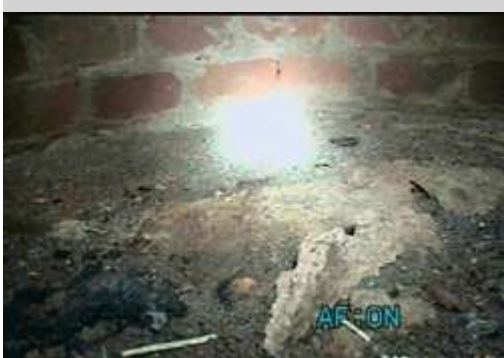
Defect 3

Condition: ☐ Sound ☐ Cracked ☐ Root Intrusion ☐ Deteriorated ☐ Leaks ☒ **Debris**

bench debris

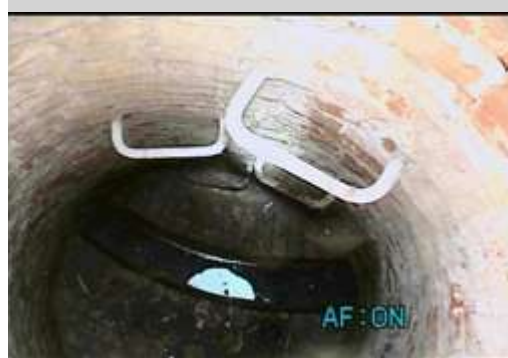
Defect 2

**Steps** Count: **4** Missing: **0** ☒ **Corroded**

steps

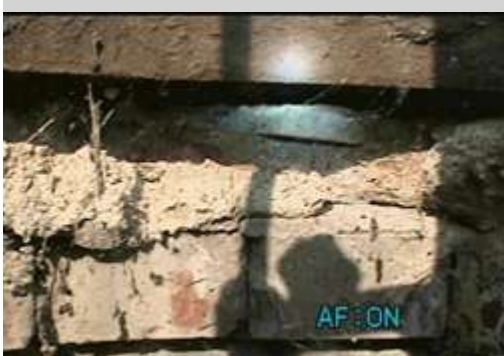
Defect 1

**Chimney / Frame Adjustment** ☒ Exists Material: **Brick and Concrete** ☐ Parged Height: **3.5** (in.)

Condition: ☐ Sound ☒ **Cracked** ☐ Root Intrusion ☐ Loose Brick ☒ **Deteriorated**

chimney deteriorated, cracked,  
frame adj

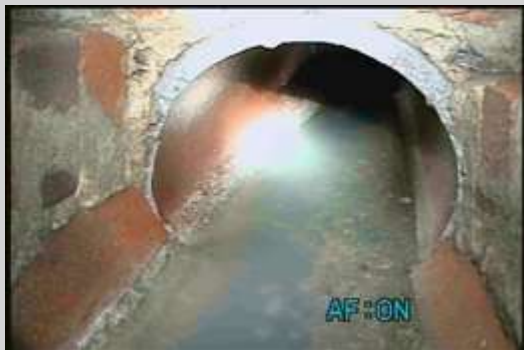
12 O'Clock Outflow

8 in. Circular Gravity Sewer  
Pipe Out @ 12 O'Clock

Pipe Material: **Clay** ☐ Pipe Lined

Invert Depth: **8.71** (ft.) Flow Characteristics: **Fast**

Deposits: ☒ None ☐ Mud ☐ Sludge ☐ Debris ☐ Grease

Infiltration: **None** Pipe Seal Cond: **Unknown**

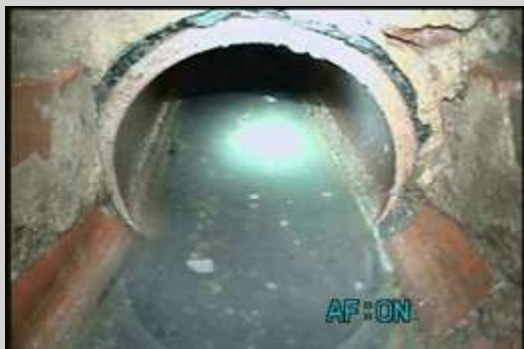
5 O'Clock Inflow

8 in. Circular Gravity Sewer  
Pipe In @ 5 O'Clock

Pipe Material: **Clay** ☐ Pipe Lined

Invert Depth: **8.70** (ft.) Flow Characteristics: **Slow**

Deposits: ☒ None ☐ Mud ☐ Sludge ☐ Debris ☐ Grease

Infiltration: **None** Pipe Seal Cond: **Unknown**
